Phase I Environmental and Geotechnical Site Assessment

Addlestone Road, Weybridge
Addlestone Road
Addlestone
KT15 2UP

November 2021

Prepared For:
Bridge Industrial
14 Old Bond Street
London
W1S 4PP

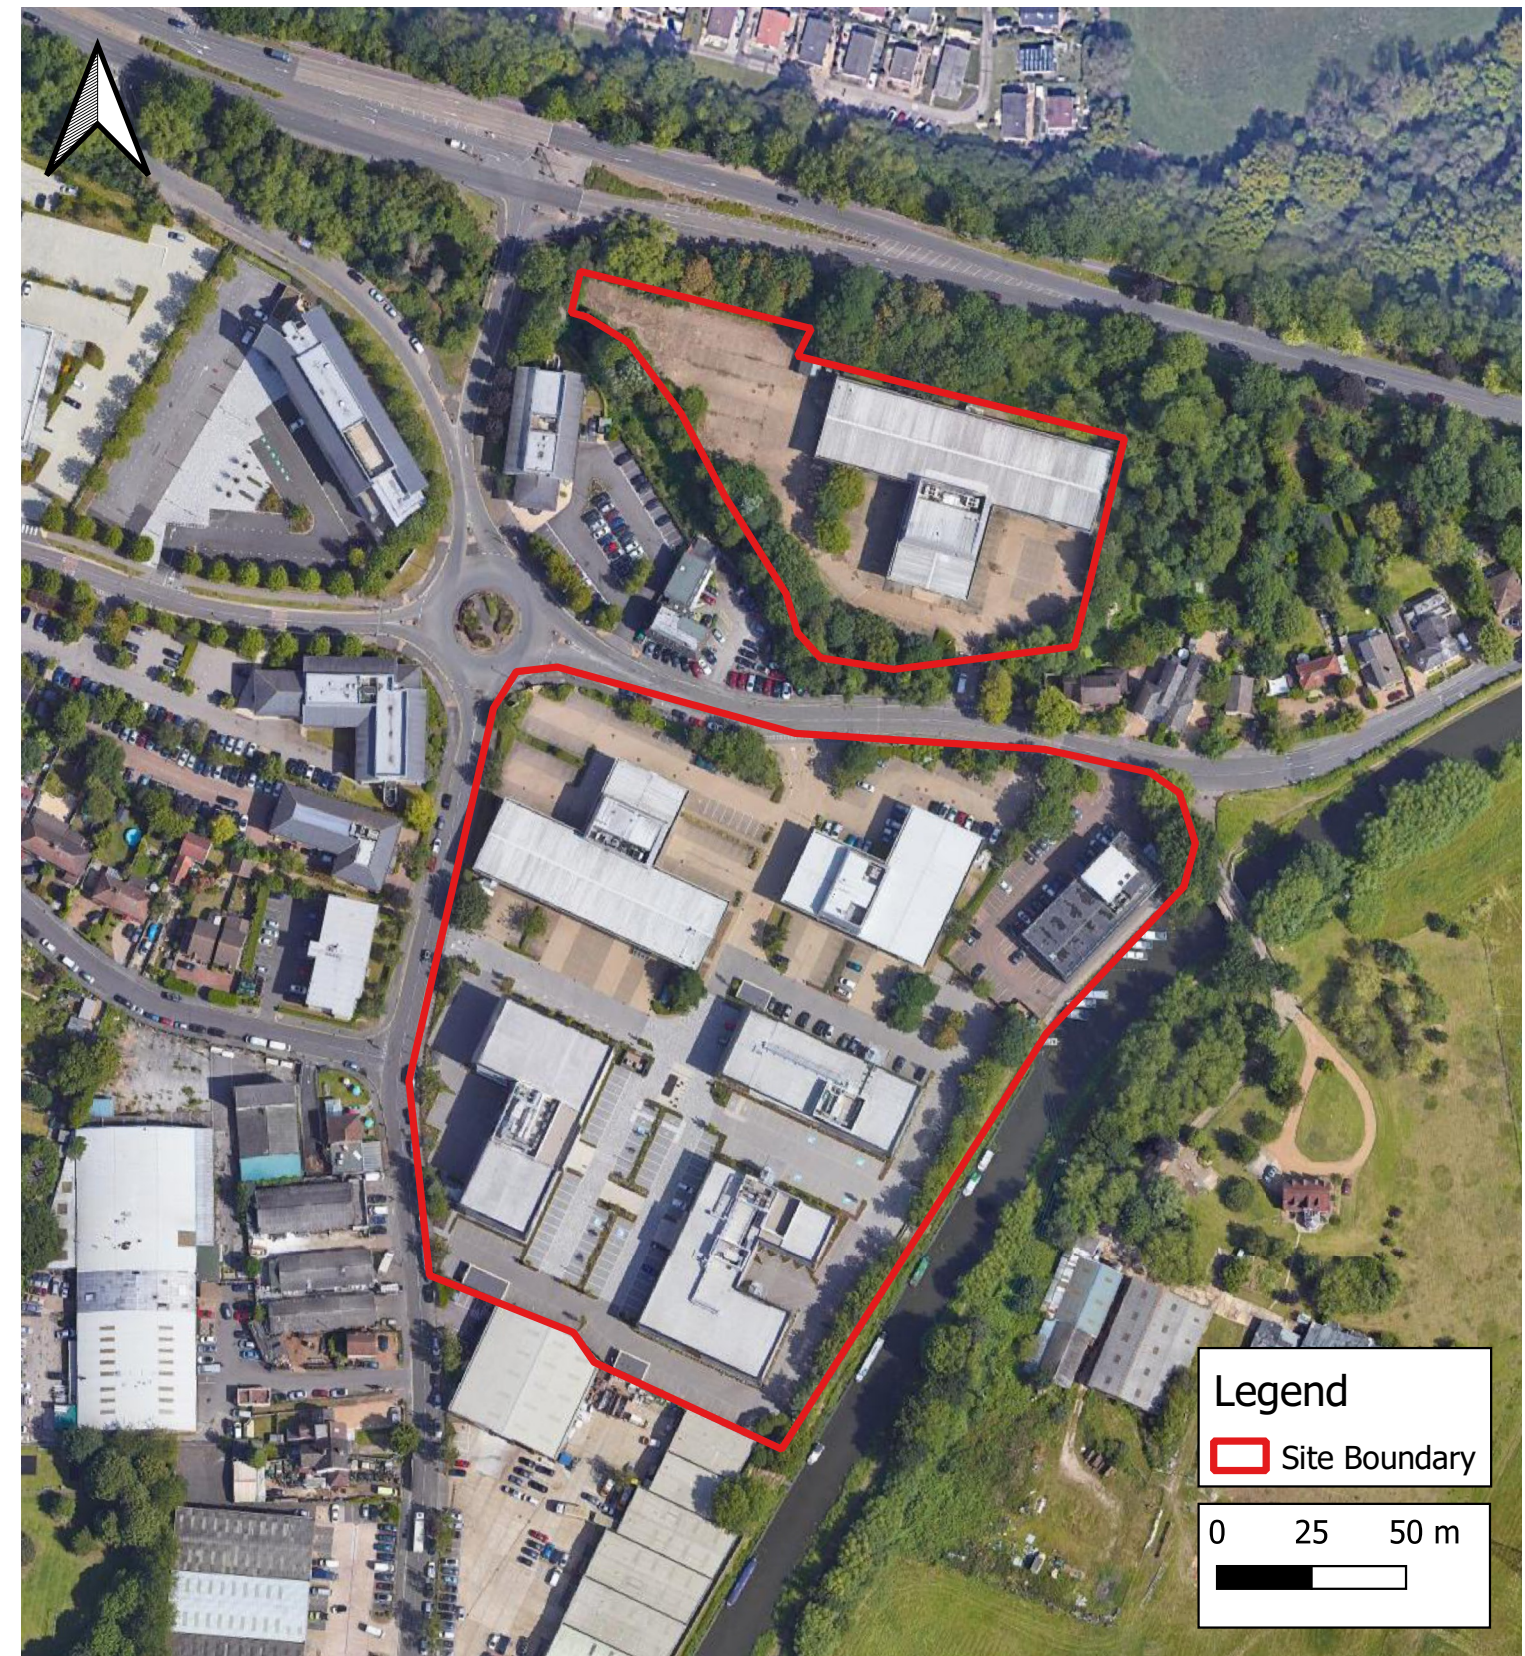
PURPOSE OF ISSUE SUITABLE FOR INFORMATION	STATUS
DRAWING NO FIGURE 01	REVISION PO1

A Site Location Plan is presented as Figure 1 in Annex A.

The Site location is presented as Figure 1 in Annex A.

The Site comprises an approximate 3.45 ha plot of land centred on National Grid Reference 506320, 164720, approximately 640m east of Addlestone Railway Station.

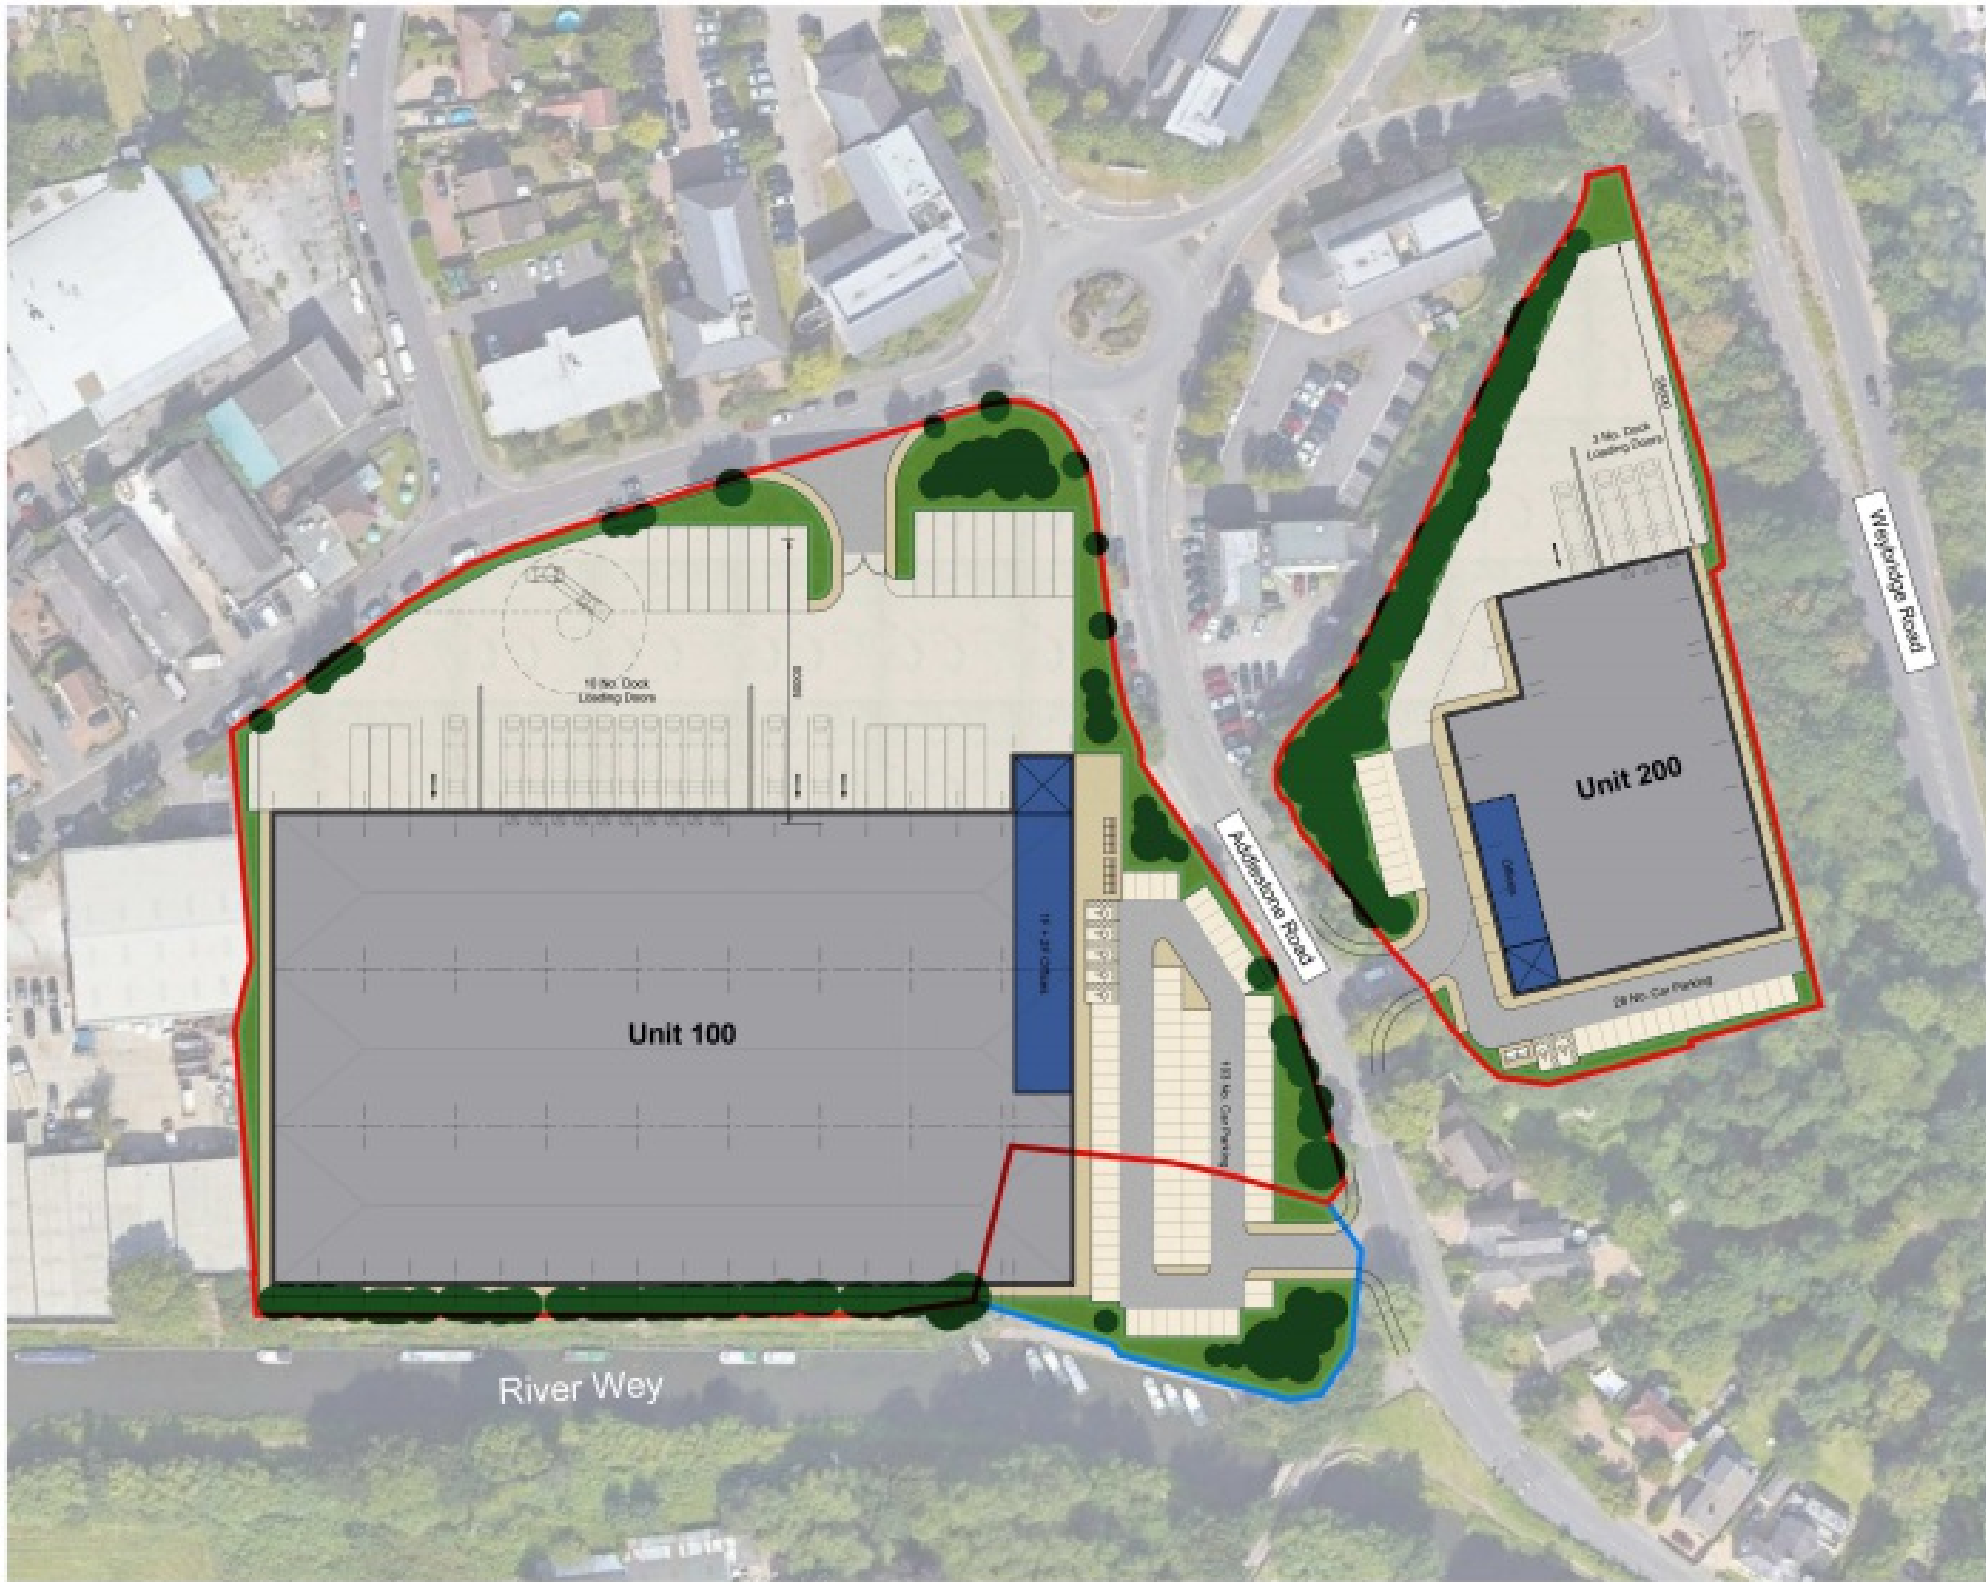
PURPOSE OF ISSUE SUITABLE FOR INFORMATION	STATUS
DRAWING NO FIGURE 02	REVISION PO1

A Proposed Development Plan is presented as Figure 2 in Annex A.

TRC understands that the proposed development will consist of two large warehouse buildings, with associated vehicle parking, loading docks, and limited soft landscaping. One of the warehouse buildings will be located in the northern portion of the Site, and the other warehouse building will be located in the southeastern portion of the Site.
