Annex C: Site Photographs

Detailed Unexploded Ordnance (UXO) Risk Assessment

Project Name	Weybridge, Addlestone Rd
Client	TRC Companies Ltd.
Site Address	Weybridge, Addlestone Rd, Addlestone, KT15 2UP
Report Reference	DA14630-00
Date	26/11/2021
Originator	CC

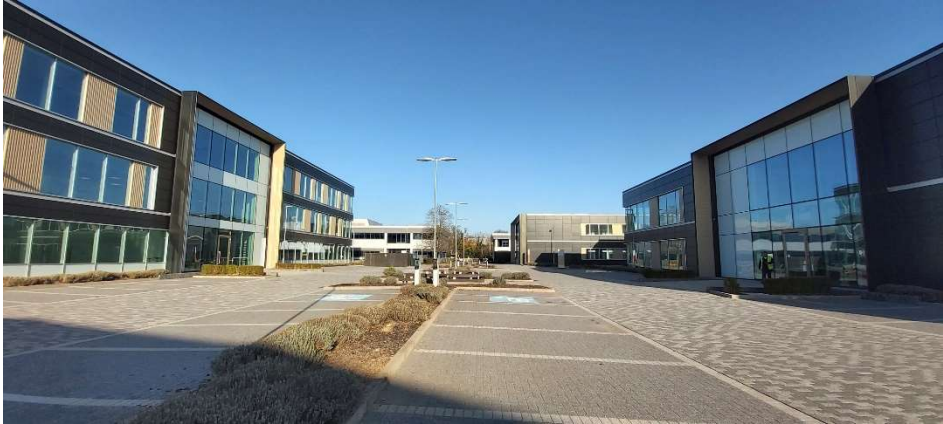
Client Name: Bridge Industrial		Site Location: Addlestone Road, Weybridge	Project No.: 470021.0000.0000
Photo No. 1	Date 23/11/2021

Description: View of the southern part of the site, looking north.			
Photo No. 2	Date 23/11/2021

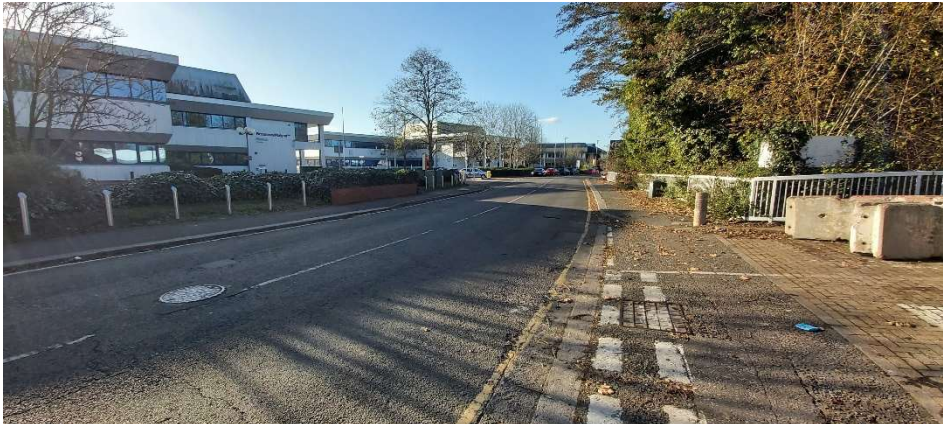
Description: View of Addlestone road, looking west.

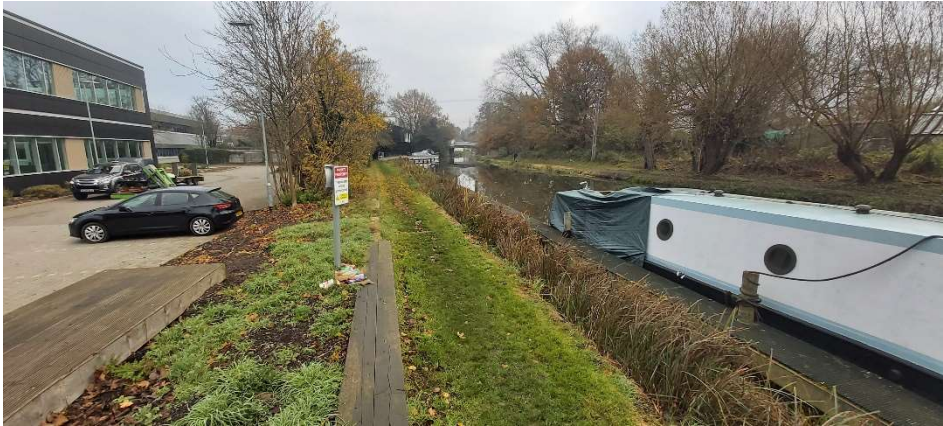
Client Name: Bridge Industrial		Site Location: Addlestone Road, Weybridge	Project No.: 470021.0000.0000
Photo No. 3	Date 23/11/2021

Description: View of the river Wey on the eastern boundary of the site, looking north.			
Photo No. 4	Date 23/11/2021

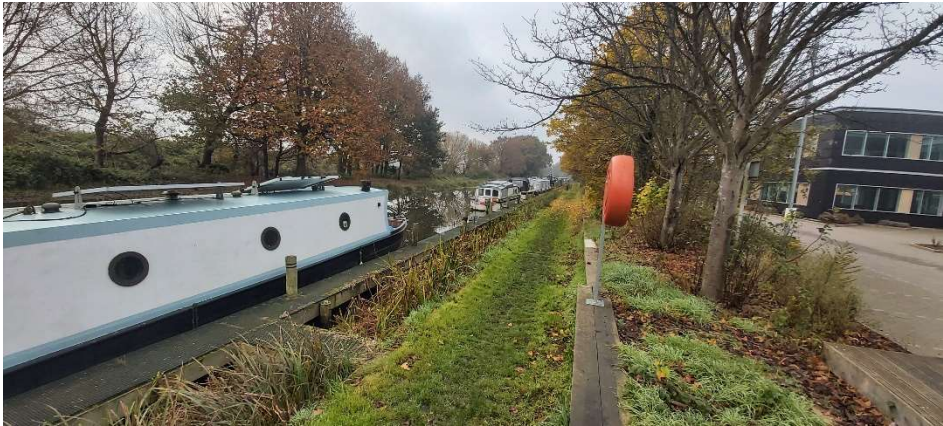
Description: View of the river Wey on the eastern boundary of the site, looking south.

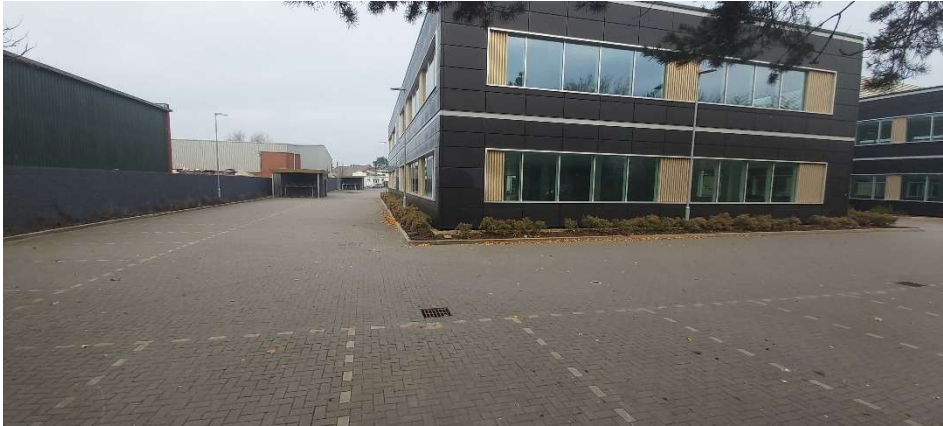
Client Name: Bridge Industrial		Site Location: Addlestone Road, Weybridge	Project No.: 470021.0000.0000
Photo No. 5	Date 23/11/2021

Description: View of the southern eastern part of the site, looking west.			
Photo No. 6	Date 23/11/2021

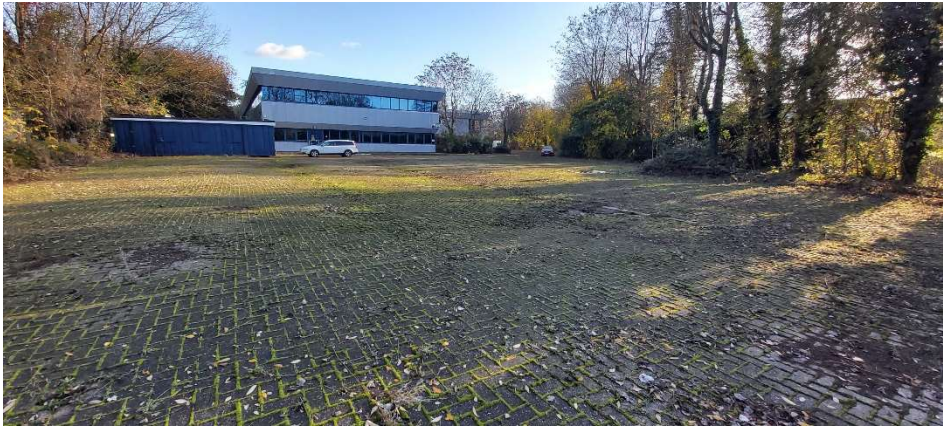
Description: View of the north western part of the site, looking east.

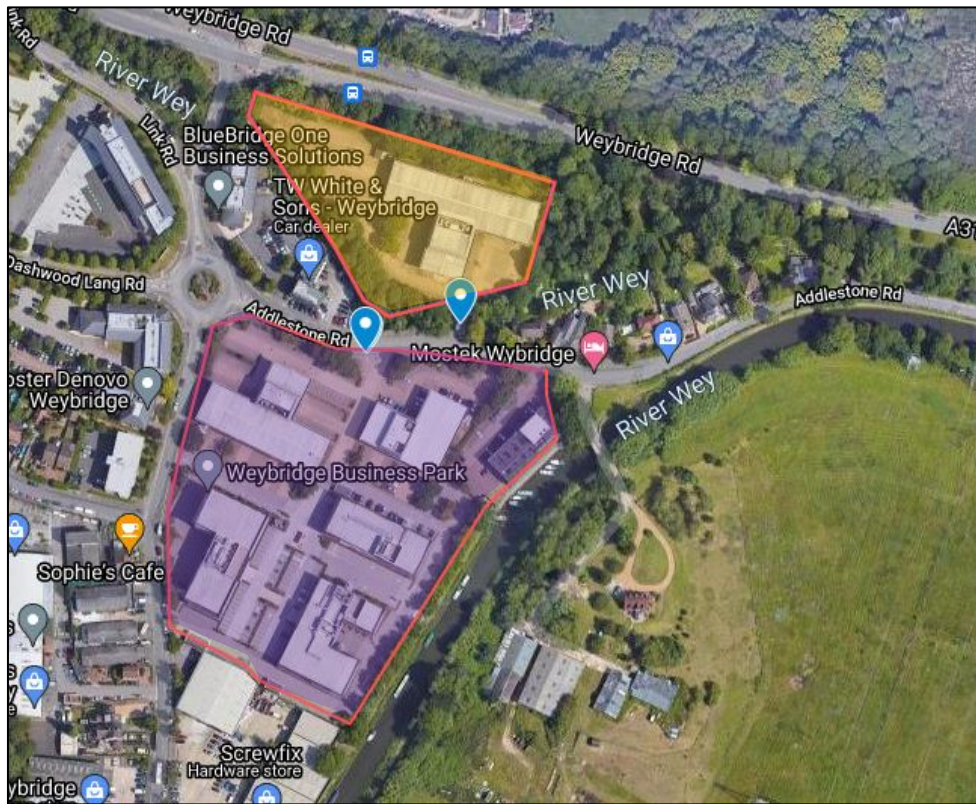
German UXO Risk Map

For indicative purposes – not to scale.

Please note that this assessed risk map may not take into account all post-war redevelopment/excavations on site.
